Test: Digital Automatic Coupling

Phase II

Test report on data communication

DAC document: 60226-06-DAC Phase II - Test report on data communication

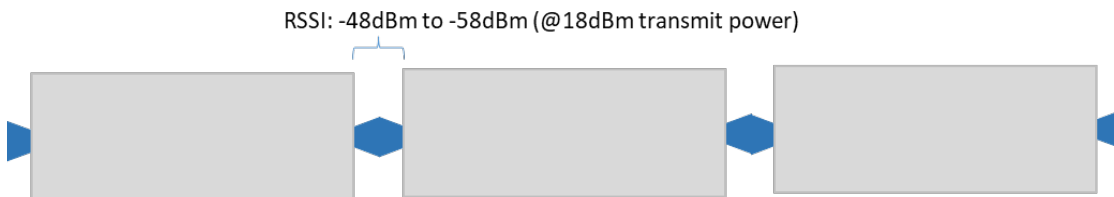
Figure 14: Reception power at the WiFi access point (measured with WiFi access point)

The line runs in Austria and Switzerland showed a very unstable WiFi communication system. Connections to the last wagon were interrupted for periods of a few seconds to a few hours. During the tests in Austria and Switzerland, a more detailed analysis of the problems was not possible due to the tight time frame. Therefore, some tests were undertaken after the line runs to identify the problems.

First, different wagon connections were examined with regard to WiFi reception performance (Figure 14). Values of -58 dBm to -48 dBm at a transmitter power output of 18 dBm were demonstrated. The values were determined by reading out the device status at the WiFi access point. The measurement of the direct attenuation of the transmission in the Berne rectangle with the antennas used was carried out in Phase I and showed an attenuation of about 45–50 dB, measured in the 2.4 GHz ISM band. The coaxial cables from the wagon box to the coupler connection box and the RF connectors must be added to the attenuation. The cables have an attenuation of about 0.42 dB/m at 2.4 GHz. Thus, in a wagon connection where a wagon box is on the opposite side of the bridged coupler, there is an additional attenuation of approx. 10 dB due to the cables. Thus, the measured reception powers are considered to be valid.

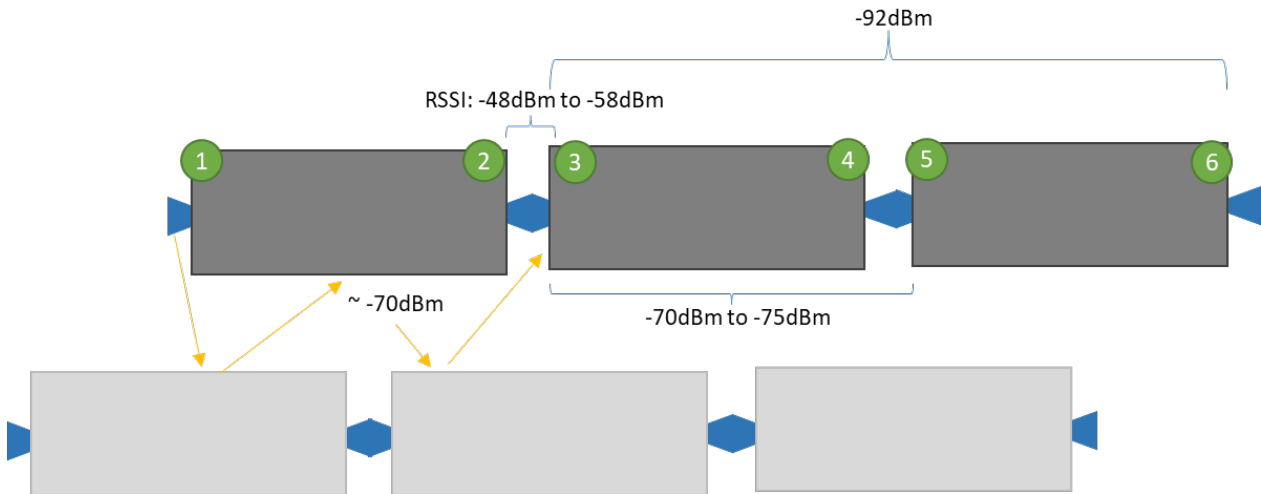
Figure 15: Measuring WiFi received power over different coupling connections

In a first measurement, the connection to the coupler (2) was interrupted. A connection from coupler (1) to coupler (3) was established with a received power of -70 dBm. A similar value could be measured for the connection of coupler 3 to coupler 5. This is an unexpectedly high received power overall, as the antennas are shielded by the massive wagons, which are earthed via the rail potential. An influence due to reflections from adjacent vehicles is considered probable. Another test resulted in a received power from coupler 3 to coupler 6 of -92 dBm. This means that this connection must be classified as poor. Therefore, the data rate was set to 1 Mbit/s by the access point in order to achieve a better SNR.

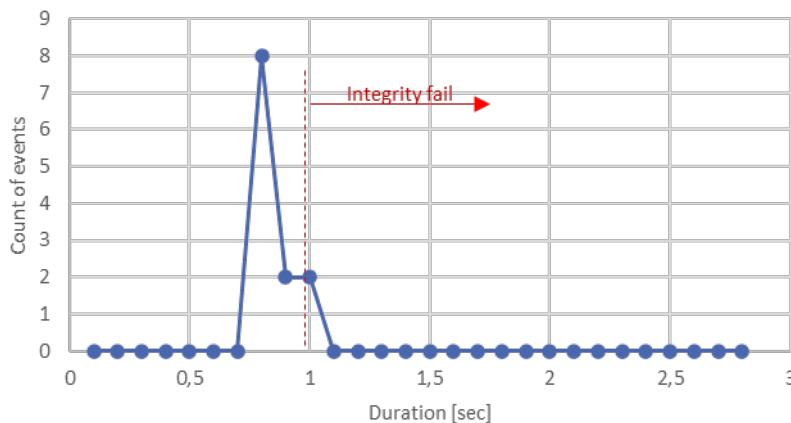
Figure 16: Occurrence of communication interruptions from Golda to Biasca

As per the analysis of the SPE packet errors, single errors also occurred during the ride, in contrast to the previous rides. This trip was the first time that a downtime > 1 second was detected, which would lead to faulty integrity detection.

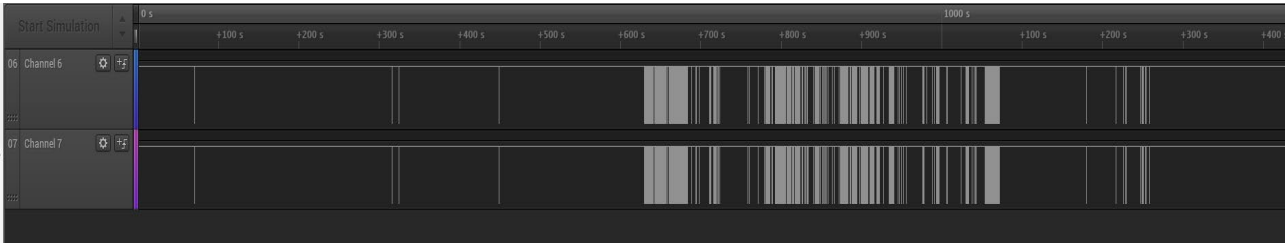
Figure 18: Disturbances with burst pulses

The set-up shown in **Figure 17** was put into operation for the first time in the measurement run from Brno to Budweis. The evaluation after the measurement run showed a high number of level changes. Since the change times of the pulses were very short, the assumption was that these were not contact interruptions, but disturbances on the line. These disturbances trigger a change of state in the logic analyser and are in the range of the sample rate (one to two sample times, 500 ns – 1 µs). Burst errors occurred frequently (**Figure 18**, **Figure 19**). The errors were identifiable on all coupling points and all cables.

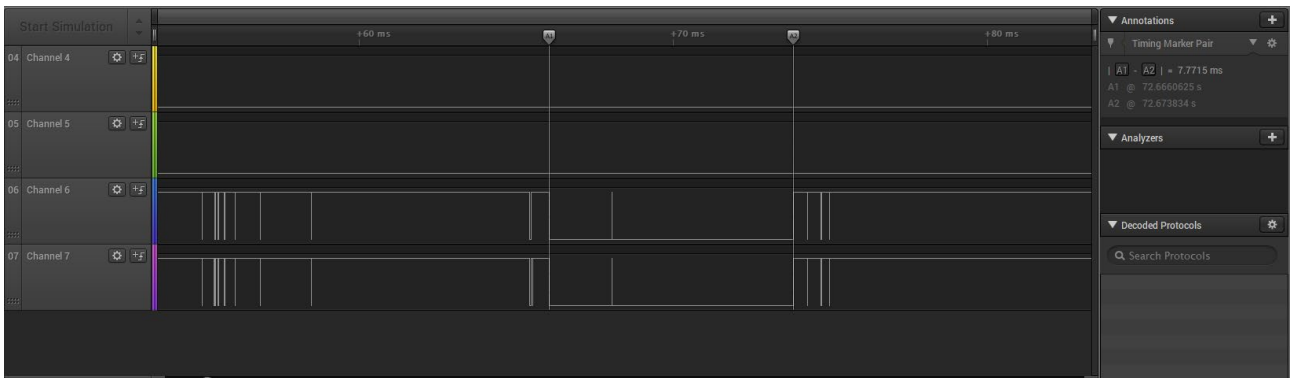
Figure 20: Section of a contact interruption (two-wire cable 1, Wg. 2 to Wg. 6)

In addition to the disturbances shown, longer dips in the pulses could also be measured (see **Figure 20**). However, this could only be observed on one pair of cables during one measurement run. The cable pair is the two-wire cable 1 from wagon 2 to wagon 6. Interruptions with a duration of 3 ms to 19 ms were detected. The number of interruptions was 11, with a measurement duration of approx. 3 hours.

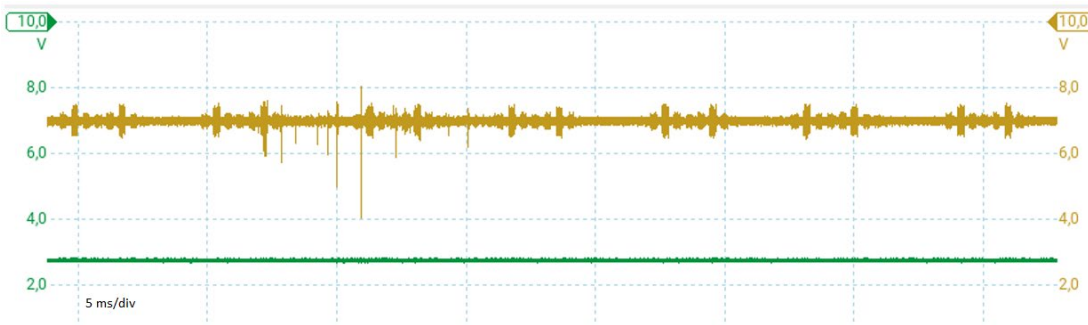
Figure 23: Recording disturbances on the power cable

- No interruptions in the communication cables were identified.
- Distinct disturbances can be seen on the power cable (**Figure 23**).
- No significant disturbances are seen on the communication cables.
- The disturbances on the power cable did not cause a link break in the SPE communication system.

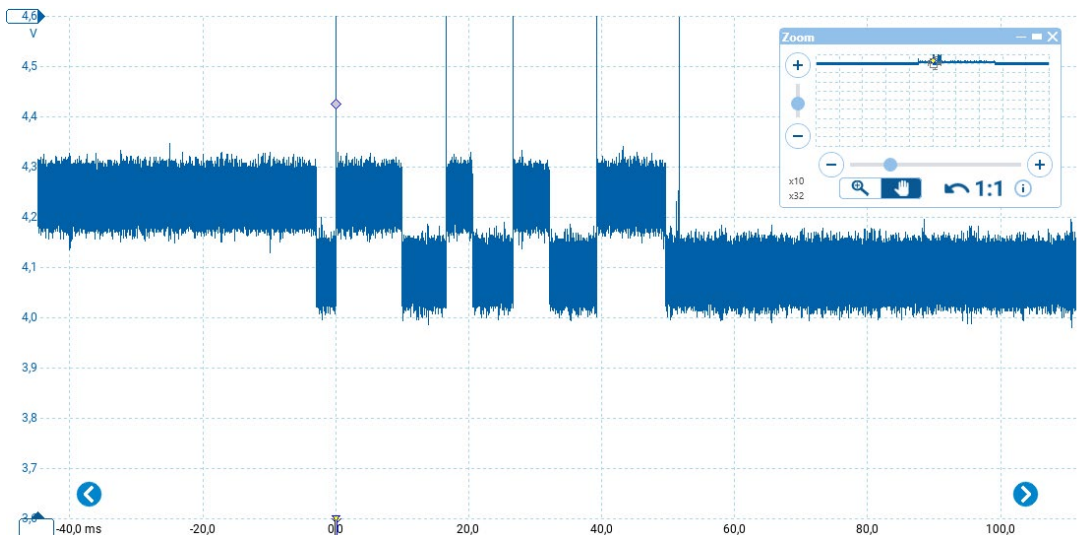
Figure 26: Measurement of a contact interruption of a known defective coupling point

The functionality of the measurement system could be observed at the start of the first Minden - Heessen measurement run. The connection to the last wagon (wagon 7) had a defective electric coupler from previous tests, which was known before (Figure 26).

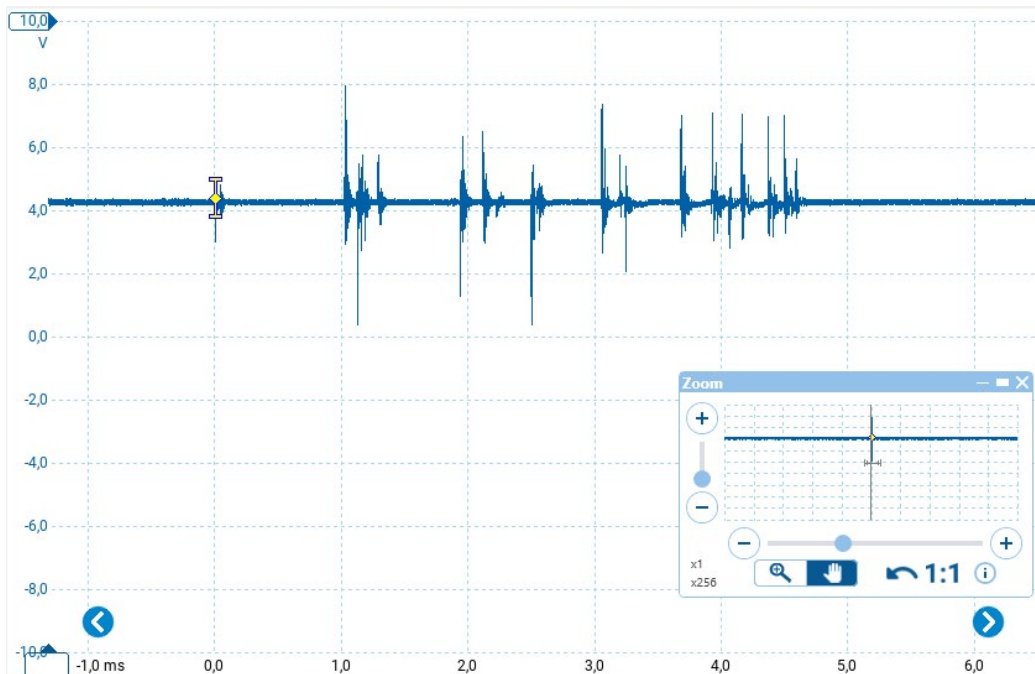
Figure 27: Interference on the continuous two-wire cable

Contrary to expectations, no other current drops could be identified at the measuring shunt that would indicate contact interruptions at other points. Disturbances on the cable were also measured, which could be due to coupling from the other two-wire cable or the power cable.

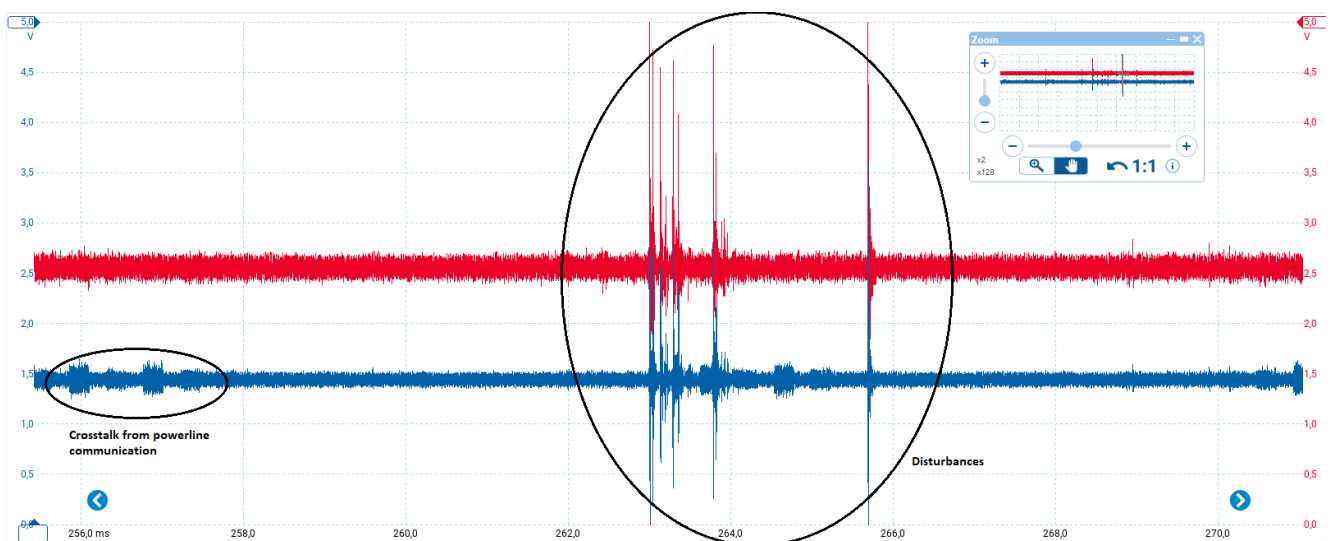
Figure 31: Measurement result of the second wagon-set

- No interruptions of the contacts could be detected,
- Crosstalk was clearly identified on the connection side (A) towards the end of the train. The Powerline-PLUS packets transmitted on the power cable stand out on the signal of the two-wire cable 2.
- Strong disturbances are detectable on both strands. Compared to the measurement of the first wagon-set (Bebra - Lichtenfels measurement run), the disturbances have a significantly larger amplitude.

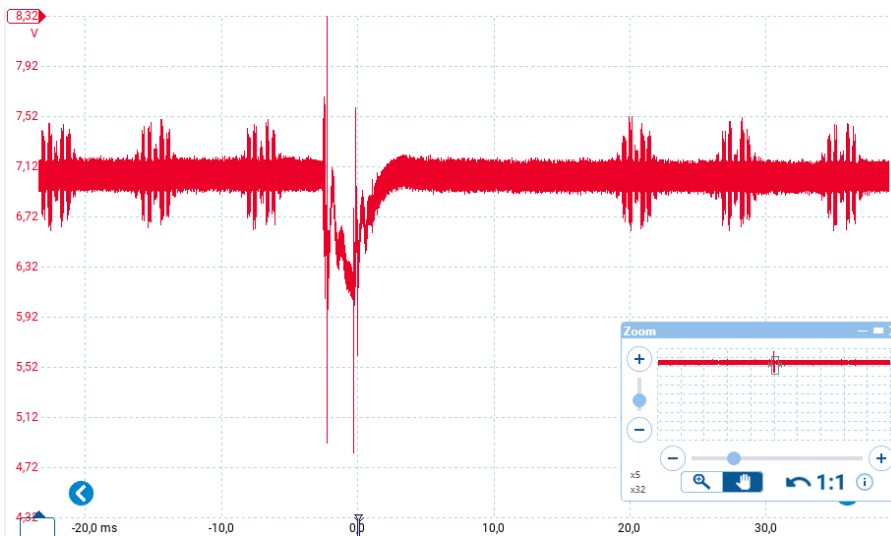
Figure 33: Voltage drop on the power cable due to contact interruption

- No interruption of the coupling contacts in the measuring loop (wagon 14 to wagon 3) of the two-wire cable 2 could be detected.
- The measurements of the power cable showed interruptions (**Figure 33**). The interruptions only occurred at the beginning of the measurement run; gentler starting and braking on the part of the driver led to lower force effects. A total of six interruptions could be recorded, with a duration of approx. 1.2 ms to approx. 6 ms. The majority of the interruptions were in the range of 1.2–2.5 ms.

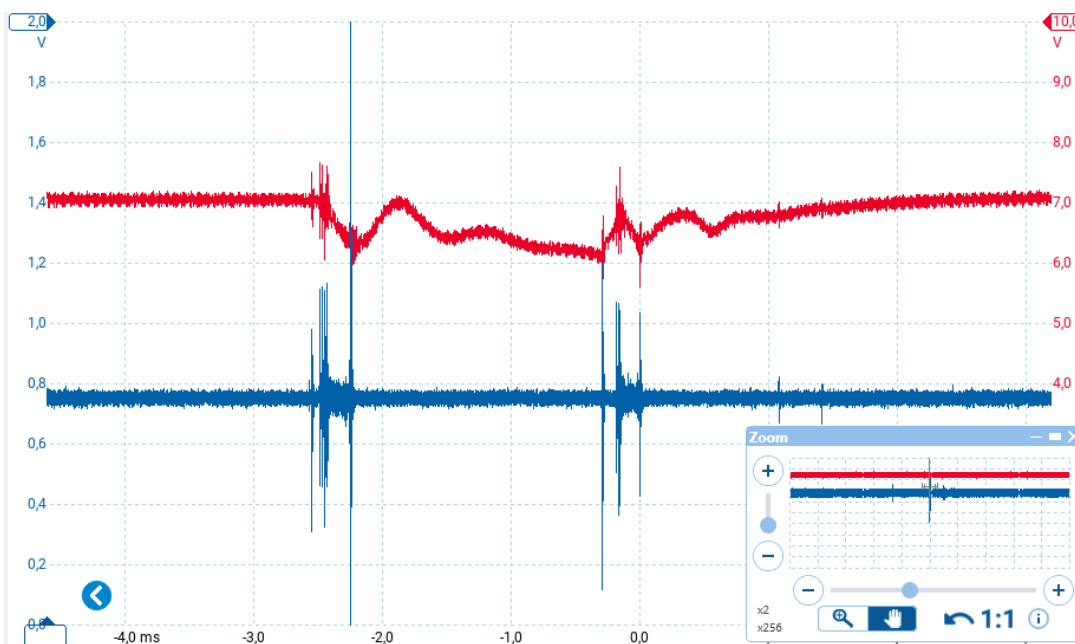
Figure 34: Disturbances on the two-wire cable at the time of the Powerline-PLUS interruption

- Significant disturbances on the two-wire cable can also be observed when the power cables are interrupted (**Figure 34**). These effects are probably not due to an interruption of the contacts of the two-wire cable. In this case, an interruption in the range of one millisecond should result in a distinct drop in the measuring current. The interference probably results from the crosstalk of the power cable onto the two-wire cable. The voltage and current peaks caused by the interruption of the power cable lead to a disturbance with a large amplitude on the two-wire cable.

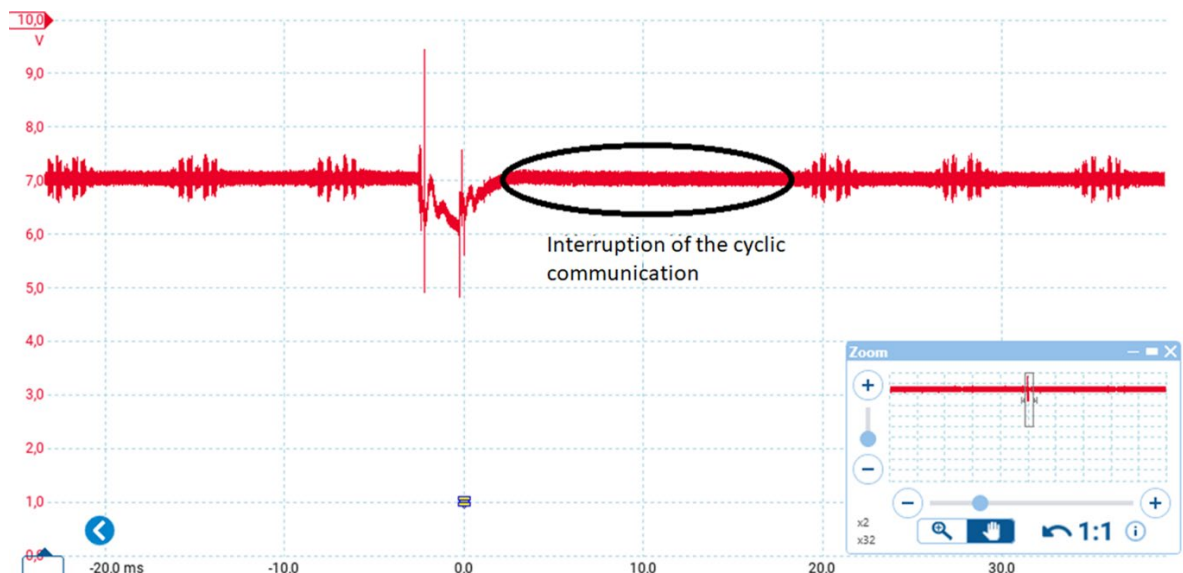
Figure 36: Influence of contact interruption on cyclic communication with the Powerline-PLUS

- There are also effects of the contact interruptions on the Powerline-PLUS communication system. In some of the contact interruptions that occurred during the transmission of a Powerline-PLUS packet, the cyclic communication was suspended for approx. 20 ms after the contact interruption. This is probably due to timeouts that add up when a packet fails. A contact interruption therefore leads to a packet loss, but this would not have any relevant influence on safety communication protocols in which resilience against simple packet losses is achieved by implementations in higher protocol layers.
