Test: Digital Automatic Coupling

Phase II

Test report on data communication

DAC document: 60226-06-DAC Phase II - Test report on data communication

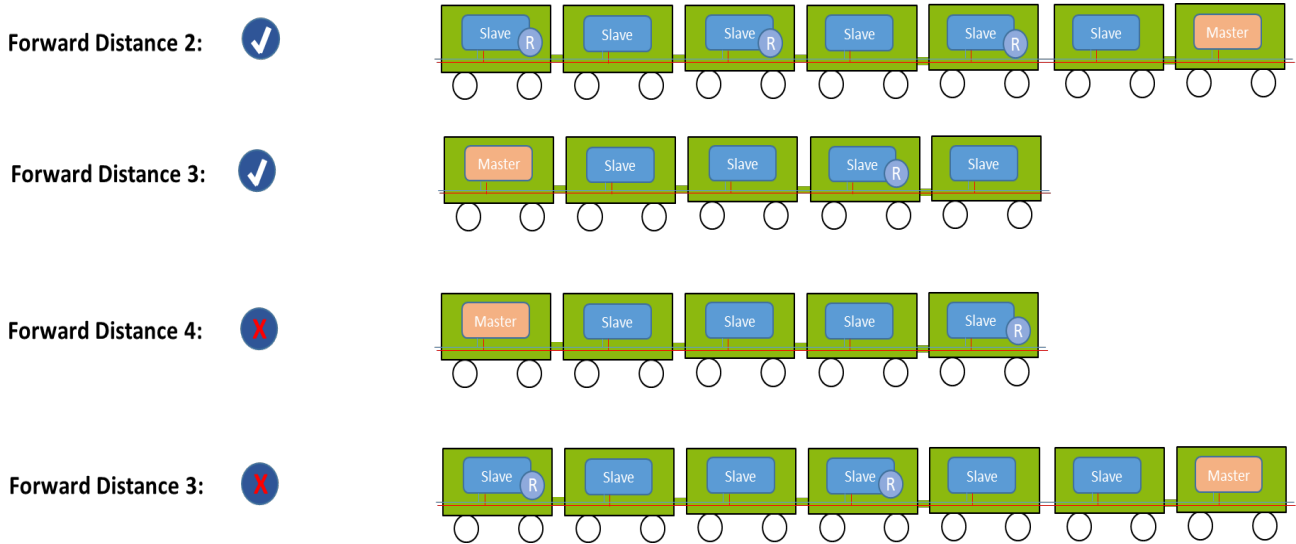
Figure 12: Test of the Powerline-PLUS forward distance in a wagon-set

With forward distance 2², the Powerline-PLUS could be operated in every wagon configuration. Forward distance 3 worked in one configuration, but in another test configuration with the master on the other side of the wagon-set, a stable connection could not be achieved. The ICMP ping communication to the last slave was only answered sporadically; the integrity check indicated an integrity error. However, the wagons in the wagon-set were correctly detected in this constellation.

Regarding the results, it must be noted that the cabling used is not optimal for use as a communication cable. In the DAC4EU wagons, two separate 16 mm² cables were used, which are routed through a corrugated tube.

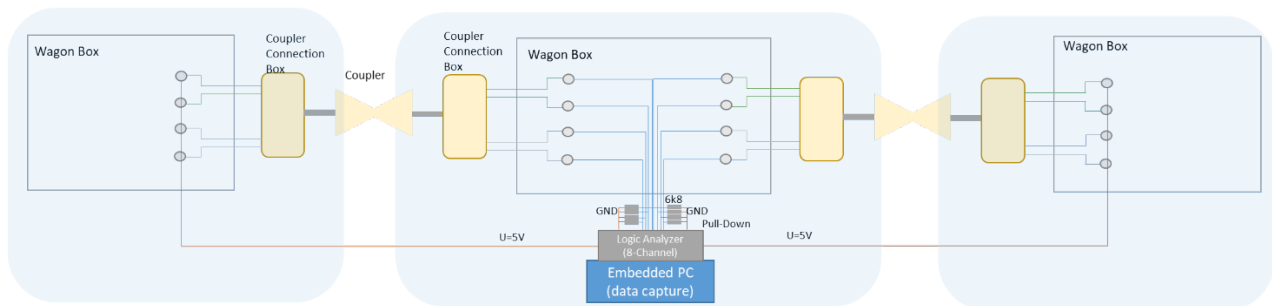
Figure 17: Monitoring contacts with a logic analyser (1)

The set-up shown in **Figure 17** was put into operation for the first time in the measurement run from Brno to Budweis. The evaluation after the measurement run showed a high number of level changes. Since the change times of the pulses were very short, the assumption was that these were not contact interruptions, but disturbances on the line. These disturbances trigger a change of state in the logic analyser and are in the range of the sample rate (one to two sample times, 500 ns – 1 µs). Burst errors occurred frequently (**Figure 18**, **Figure 19**). The errors were identifiable on all coupling points and all cables.

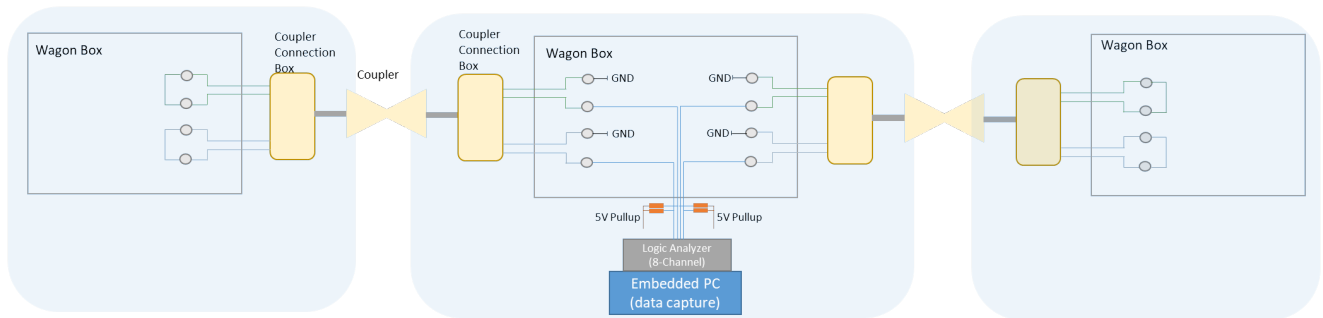
Figure 21: Monitoring contacts with a logic analyser (2)

Since the additional cables for supplying the contacts with the 5 V measuring voltage create a large conductor cable loop with the two-wire cables to be measured, interference may also have been coupled in through this. Therefore, the design was changed in that individual monitoring of the contacts was dispensed with and the two-wire cables were used as forward and return conductors of the measuring voltage.

The adjusted set-up did not result in any measurable change in the disturbances in the subsequent measurement runs. Therefore, the source of the disturbance was suspected to be coupling directly into the communication cables.

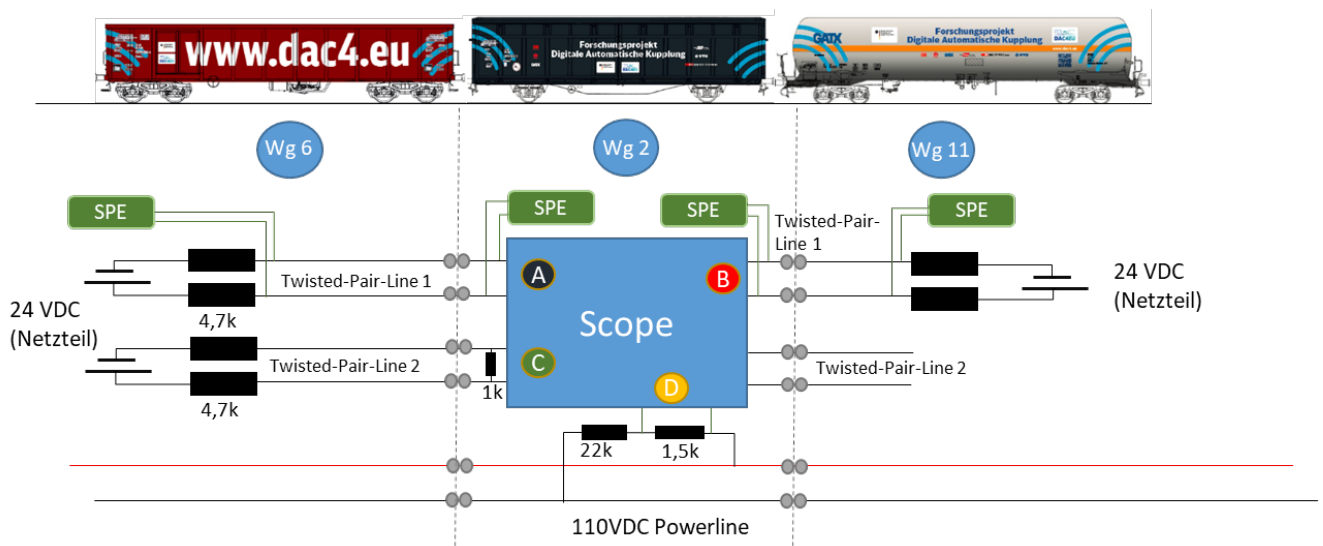
Figure 22: Test set-up for the measurement run: Minden - Saarbrücken

Two coupling points were monitored during the measurement run from Minden to Saarbrücken. For this purpose, a USB oscilloscope (Picoscope 4444) with differential probes was used to monitor a total of three two-wire connections and the Powerline-PLUS connection (**Figure 22**). Two-wire cable 1 was connected to the 24 V battery in each of the two adjacent wagons with a 4.7 kohm resistor. The internal resistances of the SPE adapters (2 kohm each) form a voltage divider at which measurements are taken in the middle wagon. The voltage in the voltage divider (1:9.4) thus forms an offset voltage which is superimposed on the SPE signal. This means that both SPEs and contacts can be monitored.

- No interruptions in the communication cables were identified.
- Distinct disturbances can be seen on the power cable (**Figure 23**).
- No significant disturbances are seen on the communication cables.
- The disturbances on the power cable did not cause a link break in the SPE communication system.

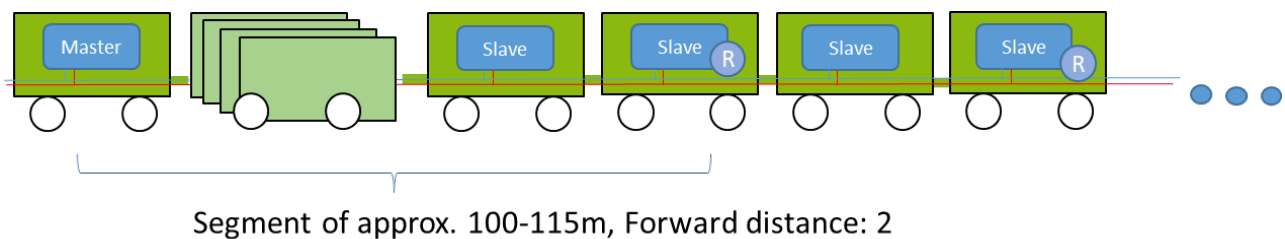
Figure 28: Powerline-PLUS with a long segment between the master and repeater slave

In addition to the measurements on the second two-wire cable for contact interruptions, the Powerline-PLUS communication system was also tested. The test case was of particular importance due to the additional ballast wagons between the measurement coach and the first DAC wagon. This increased the cable length to the first Powerline PLUS repeater slave to approx. 100–115 m. The cable installed on the ballast wagons differed from the cables installed on the other DAC wires: here, a twisted-pair power cable with a conductor cross-section of 10 mm² was used. A cable with this structure is currently favoured as a future power cable design by the EDDP committee⁴, which dealt with the power supply in the SGV. Compared to the individual cables laid loosely in the corrugated tube, it has a more constant characteristic impedance and is therefore much more suitable for communication transmission.

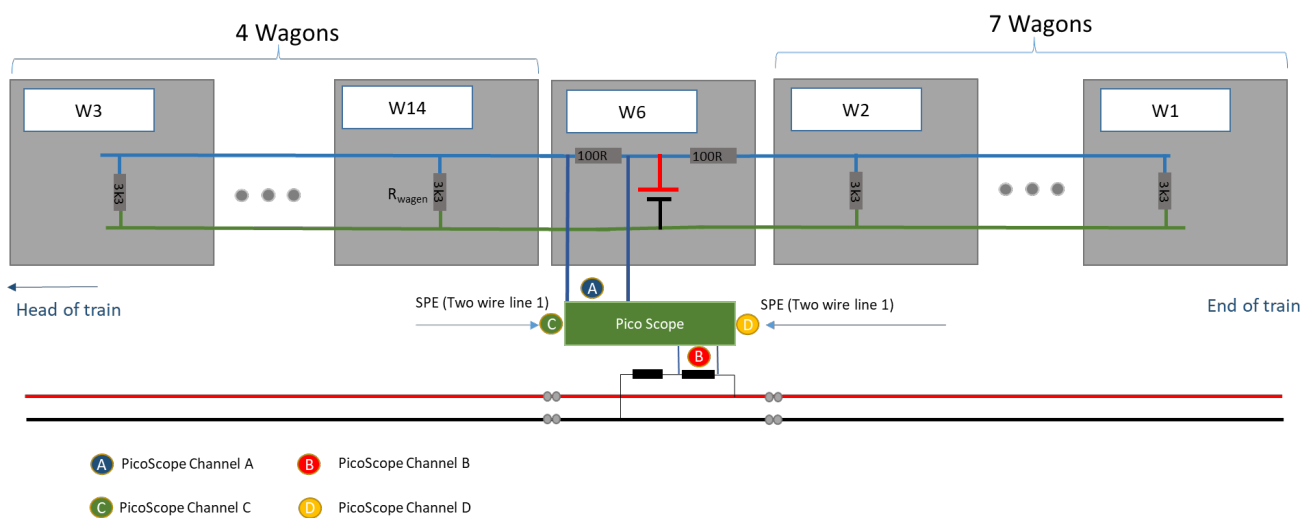
Figure 32: Structure of the measurements in the measurement run: Lichtenfels - Mannheim

During the measurement run, the set-up of the measurements was changed. The two-wire cables were now each connected directly to a measuring channel and the voltage on the power cable was monitored with a voltage divider. For this purpose, the measurement of one direction of the measuring loop along the two-wire cable 2 was dispensed with.

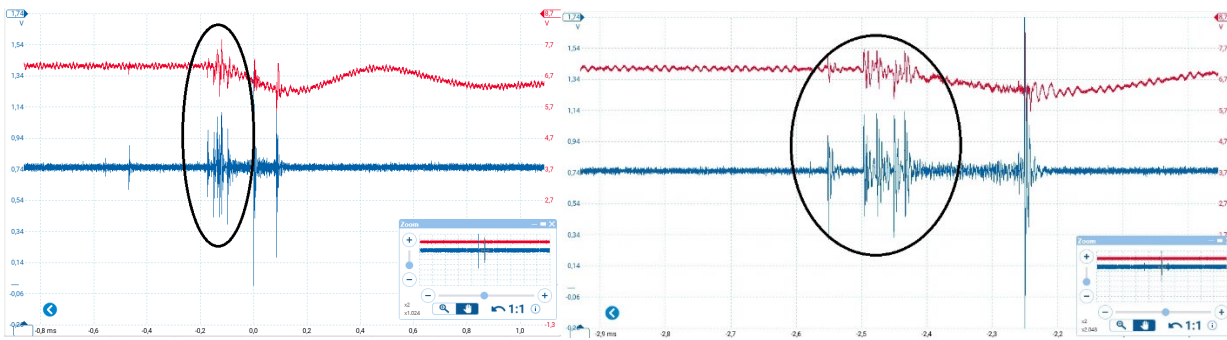
Figure 35: Disturbances before contact interruption

- The disturbances that can be observed on the power cable and the two-wire cable before the obvious contact break and the associated voltage drop are of interest: This type of disturbance is more frequently observed, even without a voltage drop. Accordingly, some of these disturbances could be a preliminary stage to contact interruption. These "near interruptions" could then cause interference with the SPE communication due to crosstalk.
